Accident to the JPM 01, “Médoc”
registered **F-PCSA**
on 6 February 2023
at Carcassonne-Salvaza aerodrome

**Reduction in engine power in initial climb, loss of control,
collision with the ground, post-impact fire**

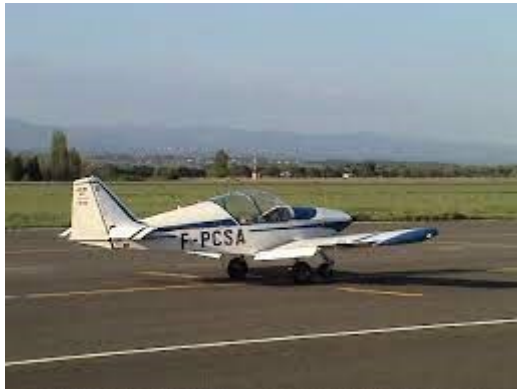
The JPM 01 “Médoc” was a single-engine, two-seater aeroplane powered by an 80 hp Limbach engine (see *Figure 1*). Its empty weight was 330 kg, and its maximum weight was 550 kg. Its construction was completed in 1996.

Figure 1: JPM 01 “Médoc” aeroplane (source: [ACAPA11](#))
